Mine Name: Bromide Basin

Inspection Report Minerals Regulatory Program May 24, 2013

Permit Number: S/017/0031
Inspection Date: 05/21/2013
Time: 10:00 am – 10:50 am
Mine Status: ACT

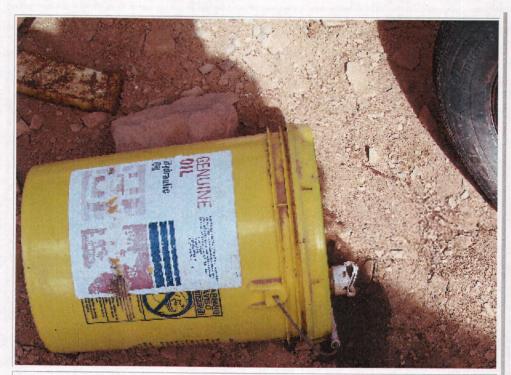
There is a waste oil drum on the site that is tipped over and leaking oil. There are buckets of hydraulic fluid that are leaking.

Some soils have been contaminated by the waste oil and hydraulic fluid and must be cleaned up.

Leaking bucker of hydraulic fluid. Notice contaminated soil.

The Division will issue a notice of violation for the oil spills.

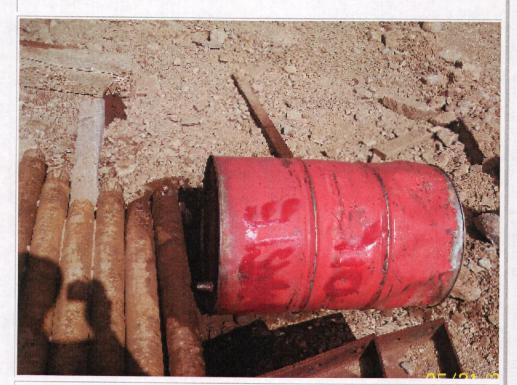
Leaking bucket of waste oil. Notice oil stains on pipe and ground

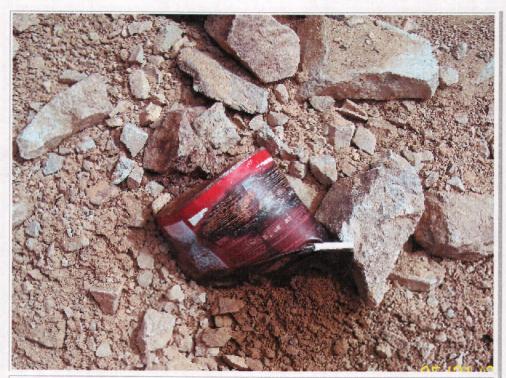
Bucket with contaminated soil.

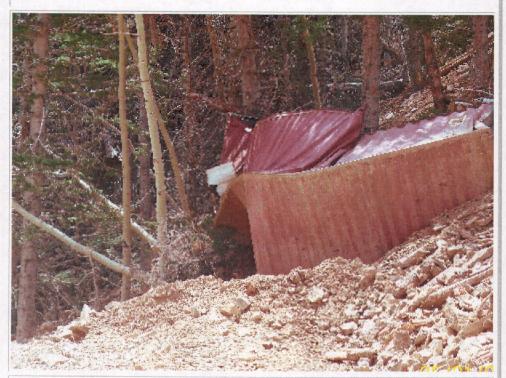
There is a large storage container that was damaged on the site an must be removed. There was also garbage on the site that must be cleaned up.

Damaged shipping container.
